PROJECT: Midnite Mine Remediation**REPORT NO:** 2021-20**OWNER:** Newmont/Dawn Mining**OPERATOR:** Newmont/Dawn Mining**SUMMARY OF WORK ACTIVITIES OR EVENTS FOR THIS REPORTING PERIOD:**

This weekly report provides a summary of Midnite Mine Site (Site) remediation action (RA) construction activities, quality assurance (CQA), quality control (CQC) and engineering activities for the period Aug 6 – 12, 2021. The Site activities discussed in this weekly report include, but are not limited to: Site Health, Safety, and Security; Community Liaison, Project Meetings, Regulatory Oversight, Site Visitors; Site Mobilization; RA Activities; Project Documentation; and Site Inspections.

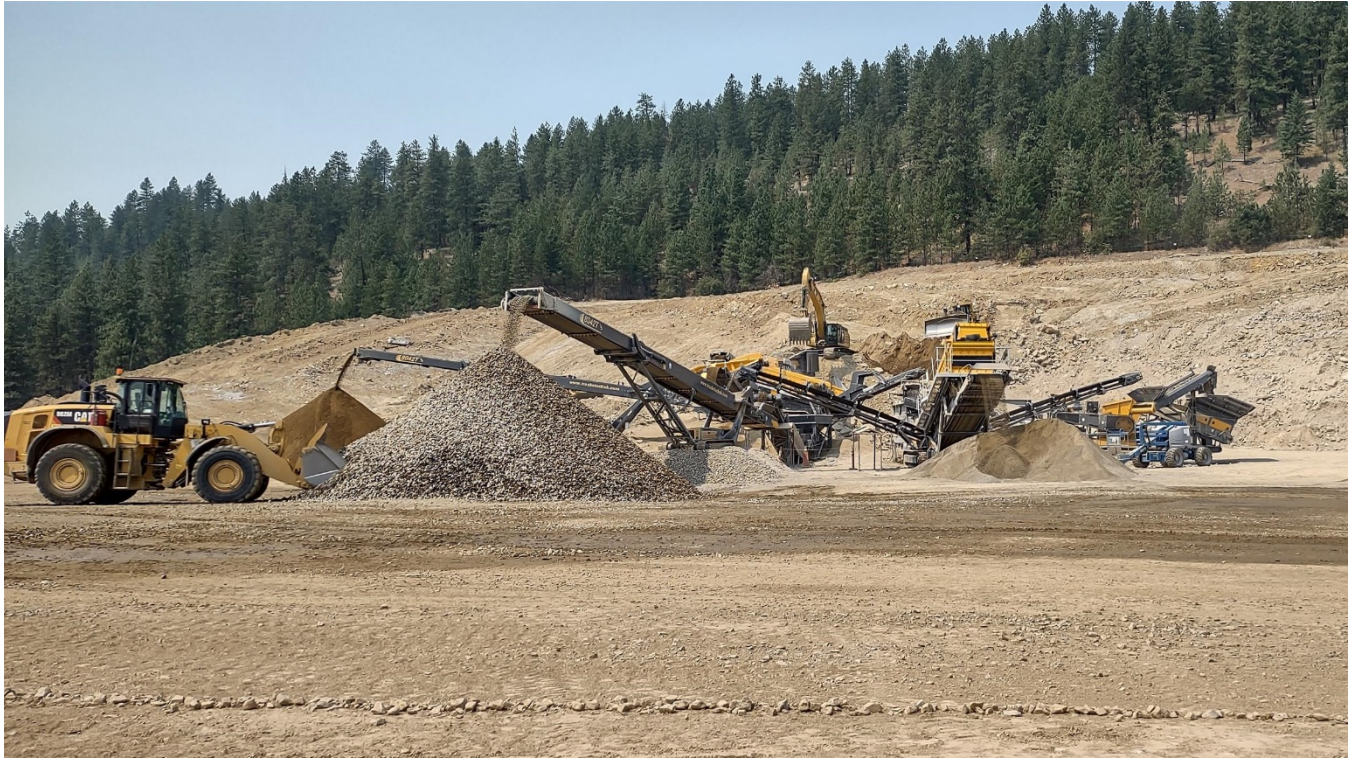
Figure 1 – Crushing and screening operations at the HSWRP.

- SLV Earthmovers continued crushing and screening material from the Hillside Waste Rock Pile (HSWRP) to produce Drain Gravel and Geomembrane Bedding Material. Newmont hauled these materials to stockpile locations designated in the 2021 Crushing and Stockpiling Work Plan (Stantec, 2021). Estimated quantities of materials produced are presented in Table 1.

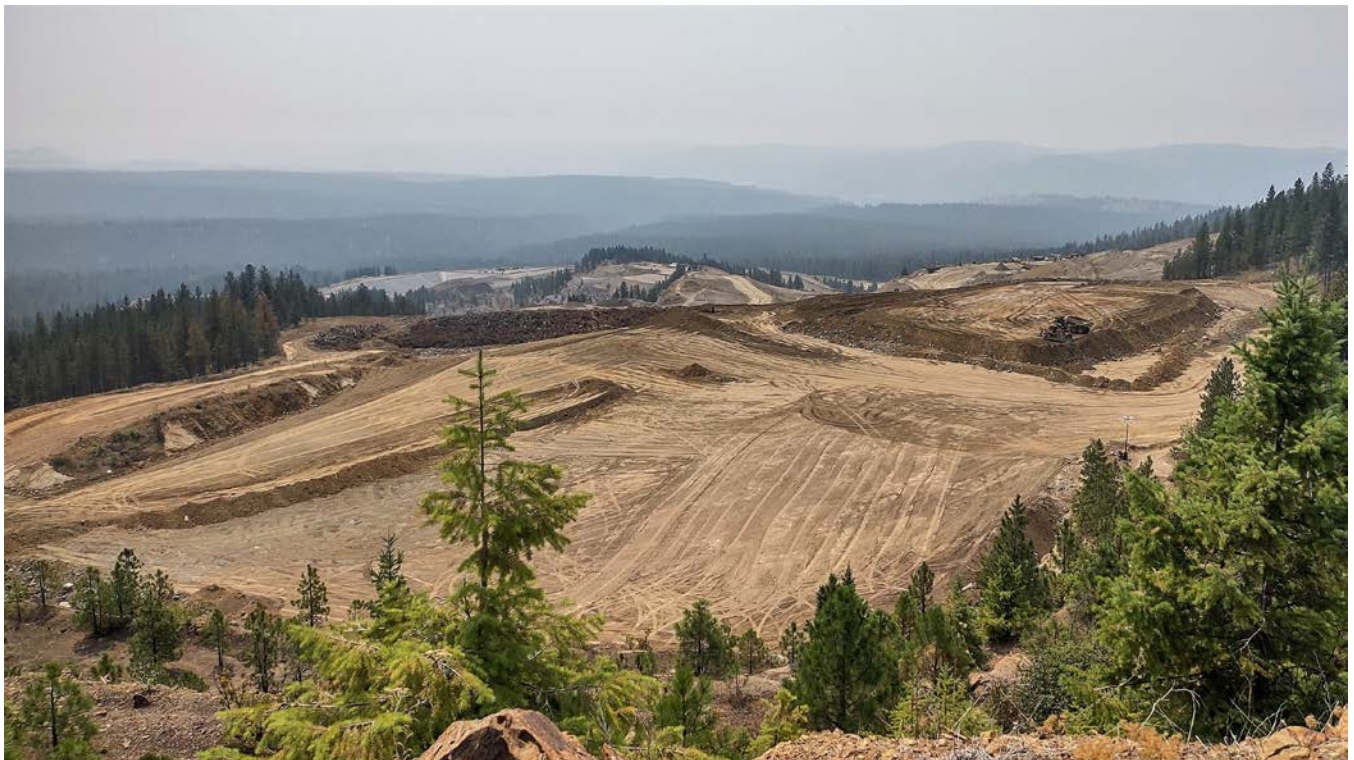
Figure 2 – Placement of low activity/low reactivity material in Pit 4.

- Newmont excavated, hauled and placed low activity/low reactivity material from the west side of the South Waste Rock Pile (SWRP) Newmont placed these materials in the Pit 4 Waste Containment Area (WCA).

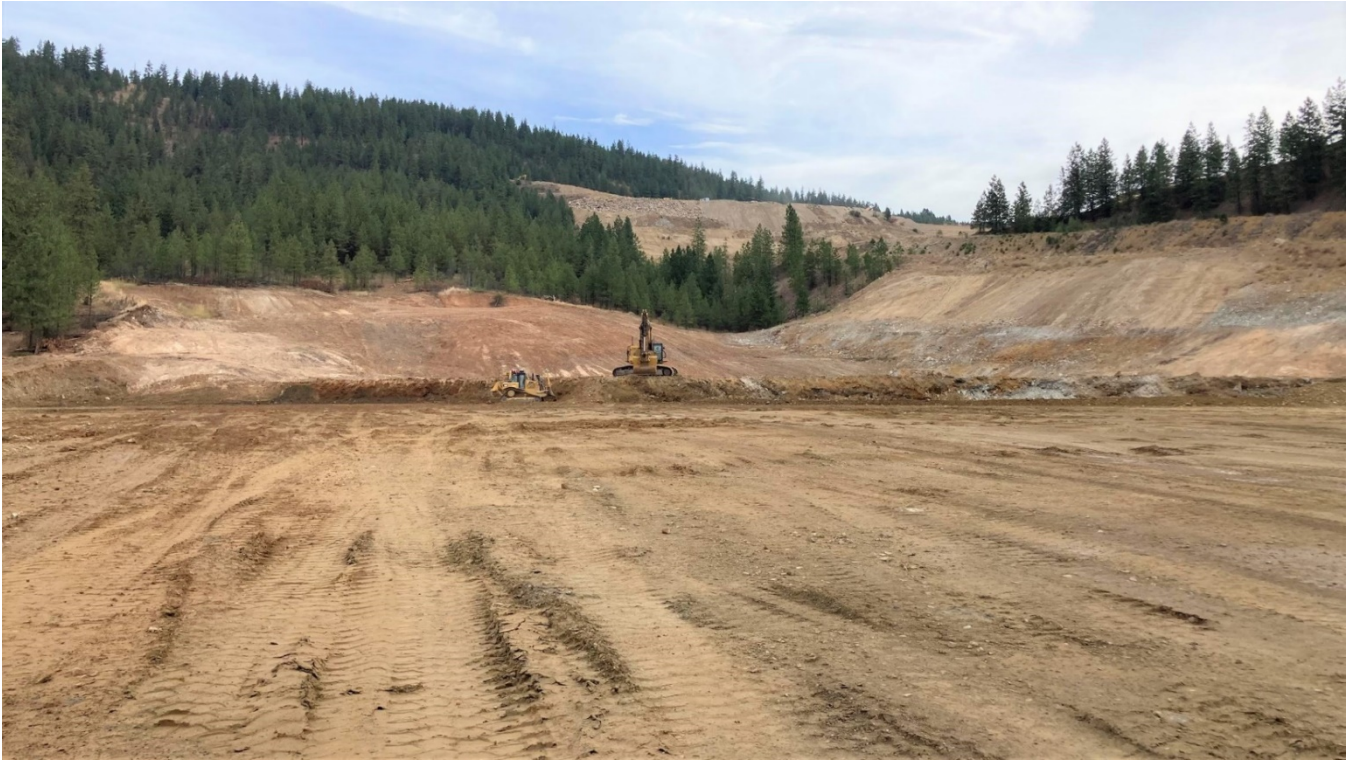
Figure 3 – Excavation, loading and hauling of low activity/low reactivity material from the SWRP, loadout 1.

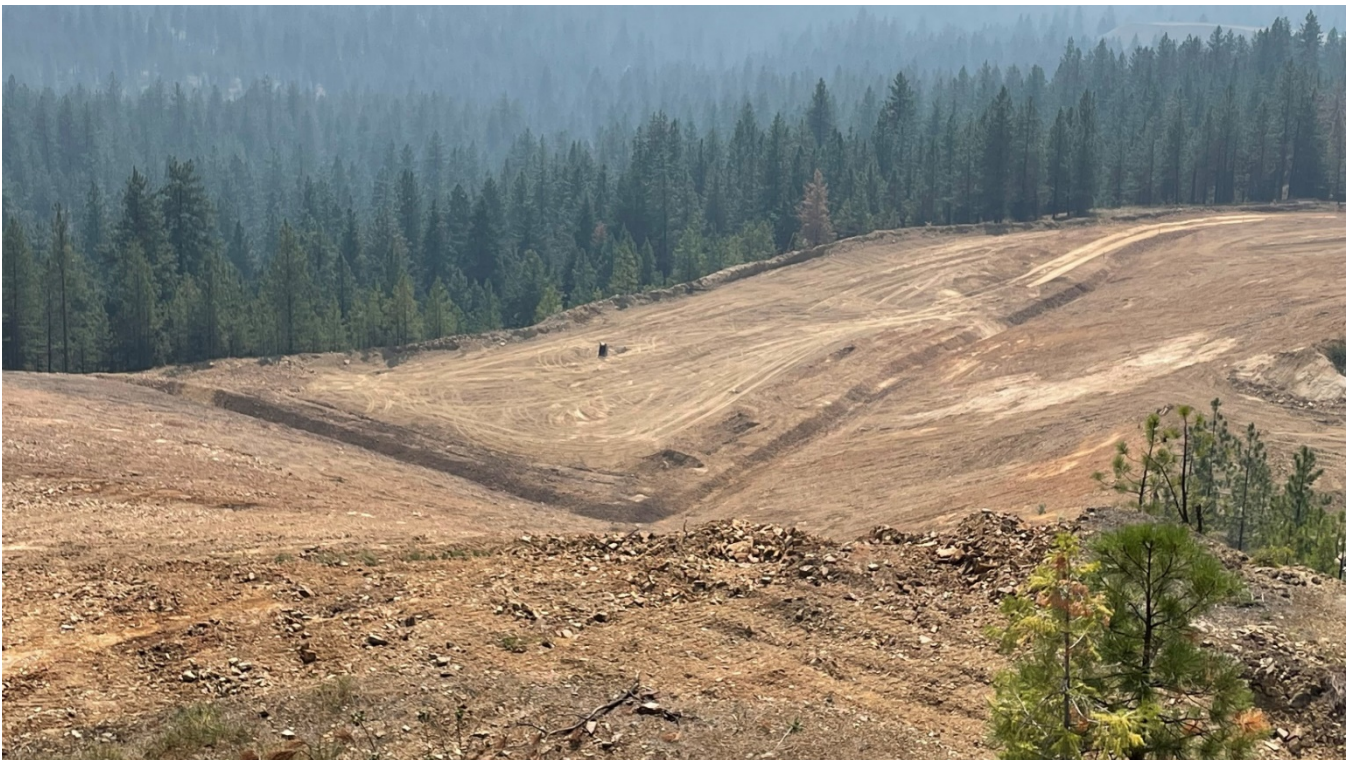
Figure 4 – Completed drainage ditch around bench along at the Pit 4 overburden, view looking southeast.

- Newmont completed excavation of the Pit 4 Overburden Pile stormwater channel. Material removed during excavation of the channel was placed in the Pit 4 WCA.

- Newmont completed excavation of the Pit 4 Overburden Middle stormwater channel.

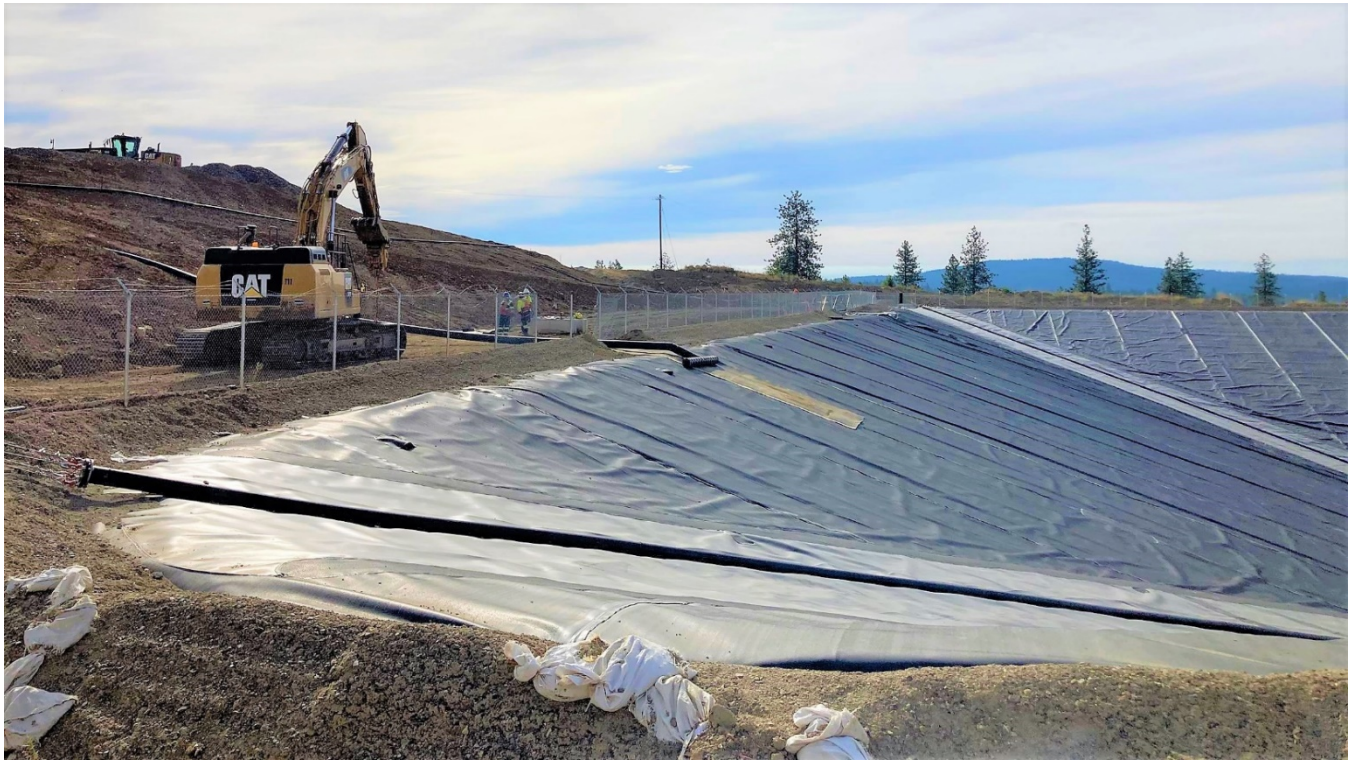
Figure 5 – Pit 3 dewatering pipe with TEE installed to discharge into the South Pond.

- Newmont began installation of the Pit 3 dewatering pipeline. The 10-inch HDPE pipeline was installed from the edge of water in Pit 3 to the South Pond. The diffuser end was installed in the South Pond in accordance with the *Pit 3 Dewatering Work Plan* (Stantec, 2021).

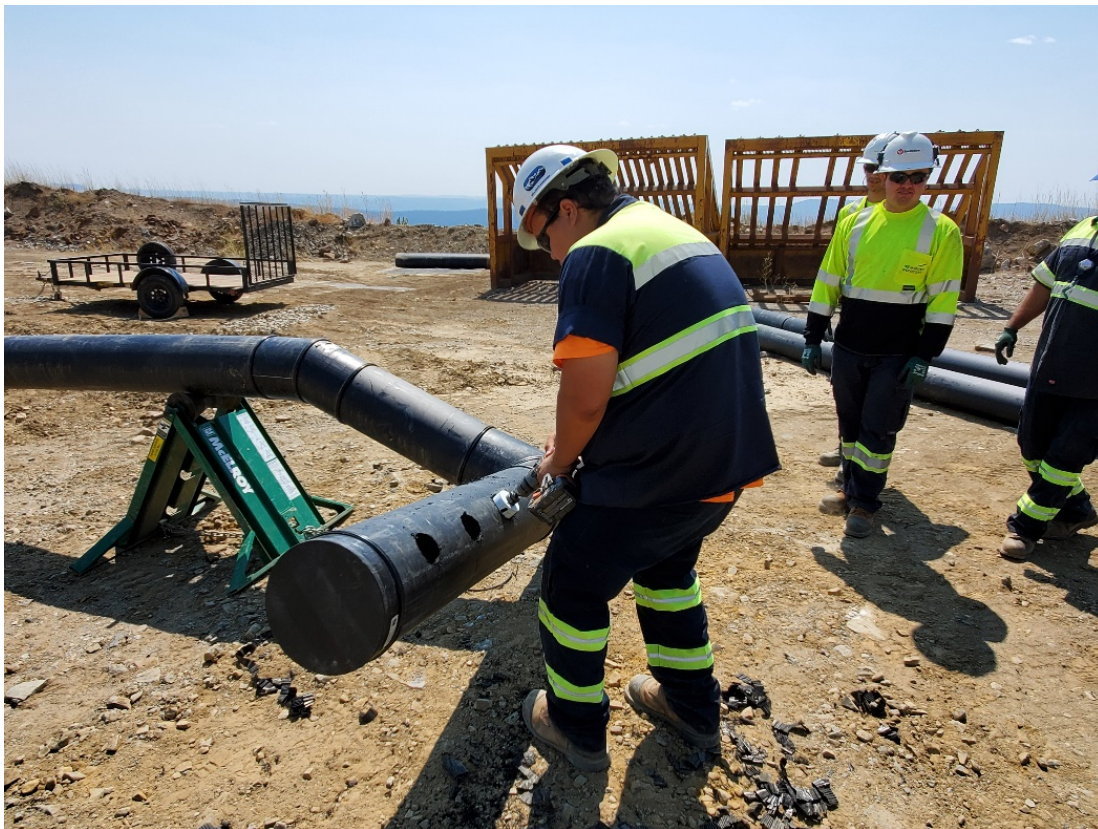
Figure 6 – Utility Crew preparing the Pit 3 Dewatering Pipeline diffuser tee

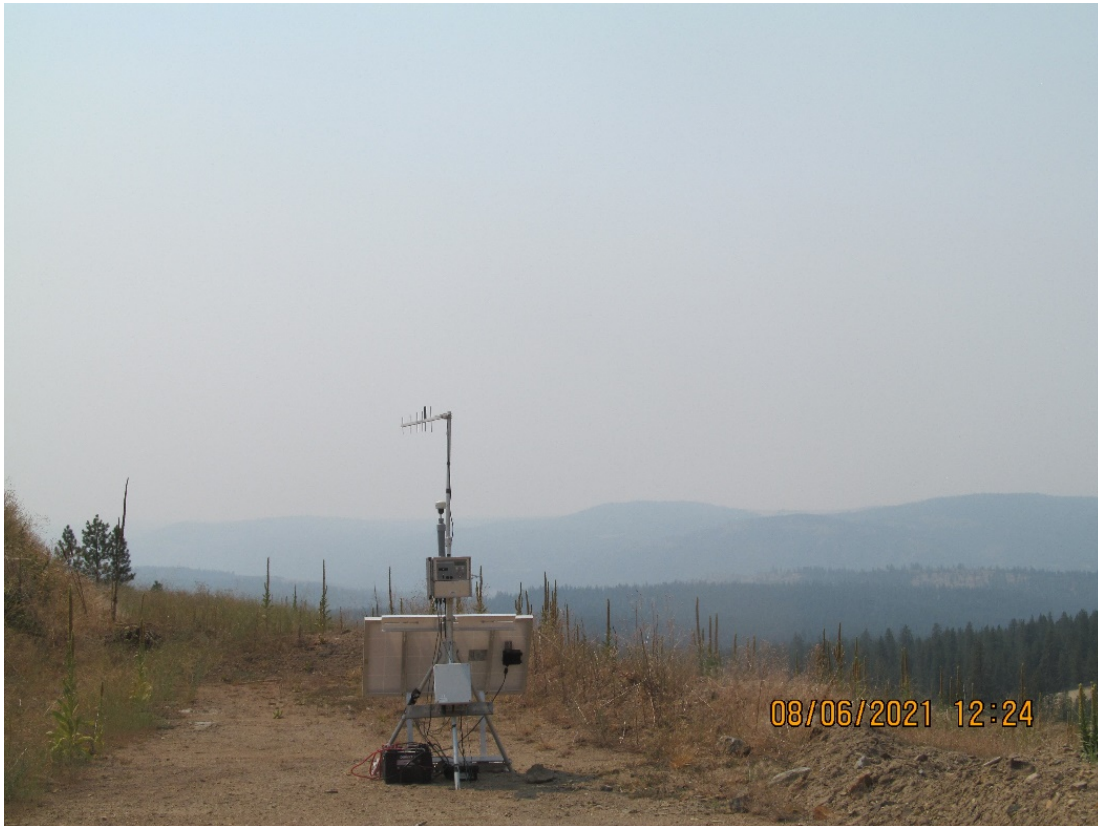
Figure 7 – Smoky conditions as seen from dust monitor ES-6, looking south

All eight dust monitors were turned back on Monday (8/9/2021) but were turned off again on Wednesday night (8/11/2021) at approximately 8:30 p.m. due to alarms received from smoke due to a combination of local area and regional fires. Monitor locations and operating time-periods are as shown in Table 2 below. All three water trucks (2,200, 4,000 and 9,000-gallon capacity) were used for dust suppression as needed during mine site construction activities. Construction activities for the Effluent Pipeline restarted on Monday (8/9/2021).

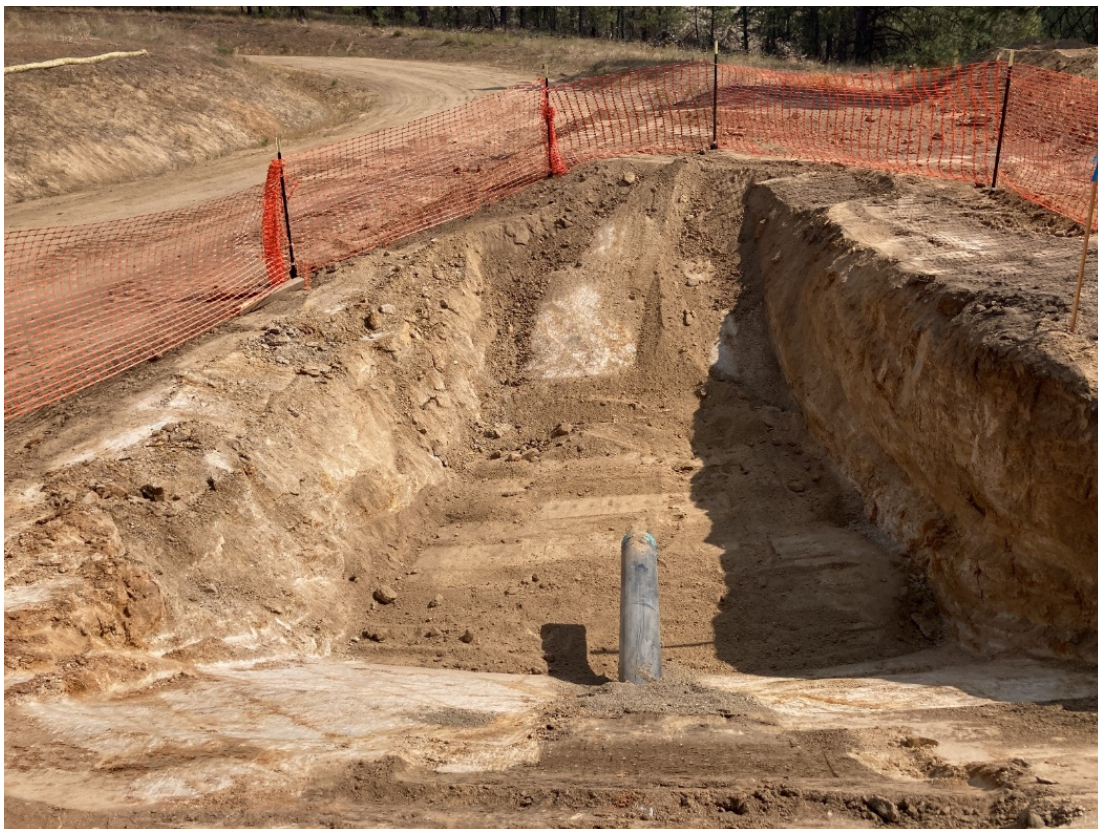
Figure 8 – Excavation at Station 14+63 – first manhole location on the Effluent Pipeline

- Halme Construction resumed Effluent Pipeline construction activities. Work activities included:
 - Pipeline installed to Station 45+55.
 - Prepared for manhole installation at Sta 14+63. Manhole has not been installed.

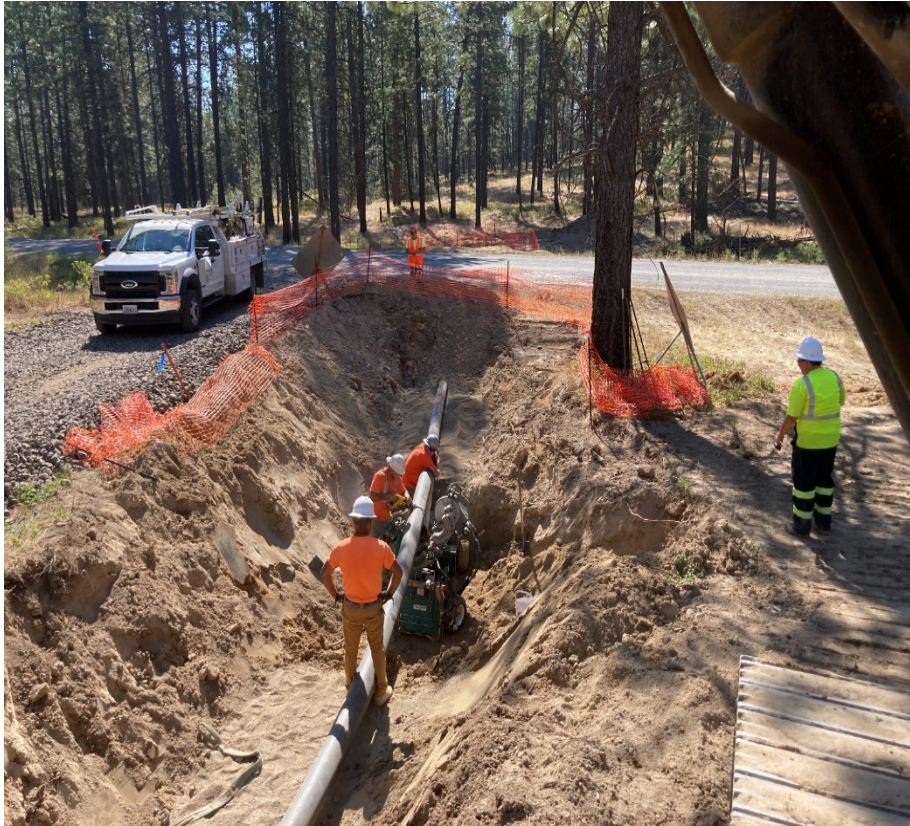
Figure 9 – Welding Effluent Pipeline to the pipeline under West End Road

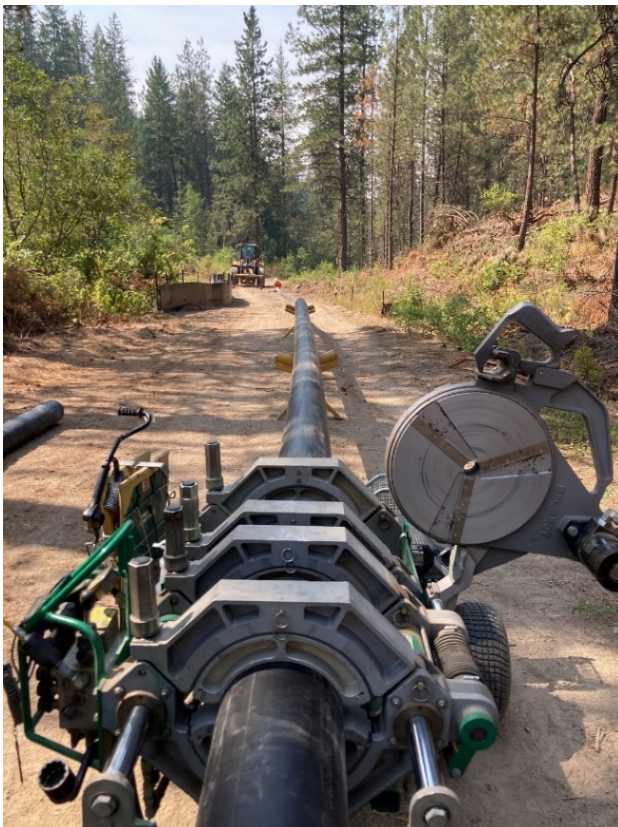
Figure 10 – Welding Effluent Pipeline pipe along Blue Creek Road

- Started fusing pipeline down Blue Creek Road.
